Achieving zero leaks on a budget

By Abigail Gilson-Beck and Glen Toepfer

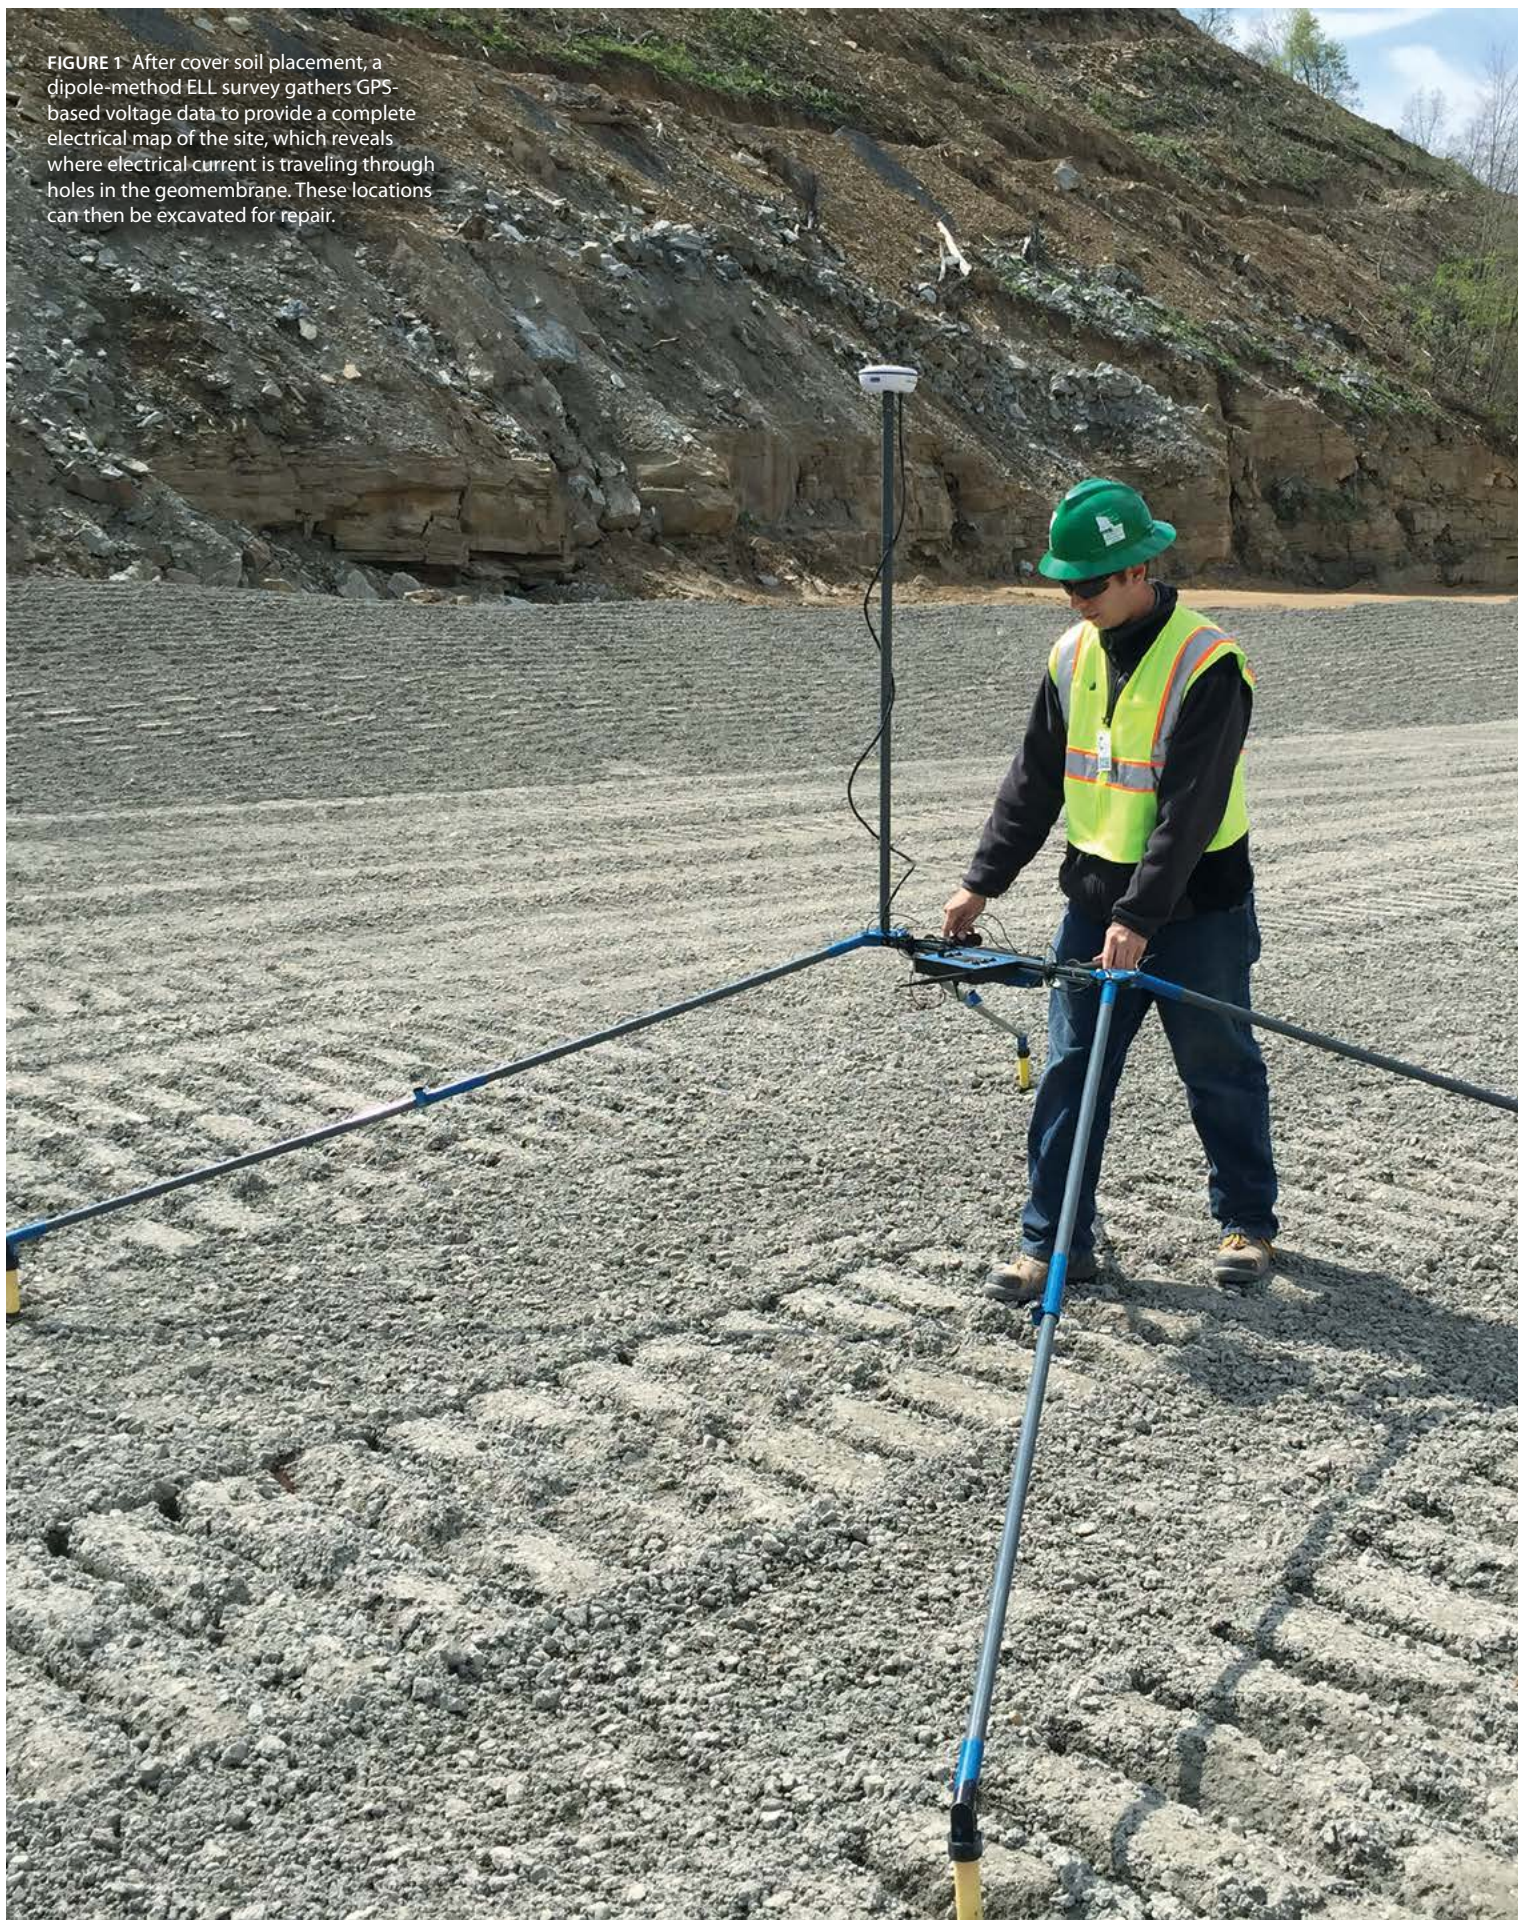
FIGURE 1 After cover soil placement, a dipole-method ELL survey gathers GPS-based voltage data to provide a complete electrical map of the site, which reveals where electrical current is traveling through holes in the geomembrane. These locations can then be excavated for repair.

If the geomembrane is to be covered by soil or water, a voltage map can be created as part of dipole testing, providing a valuable CQA document showing that the lining system was constructed free of leaks or that the leaks were identified for repair, as shown in **Figures 1 and 6**.

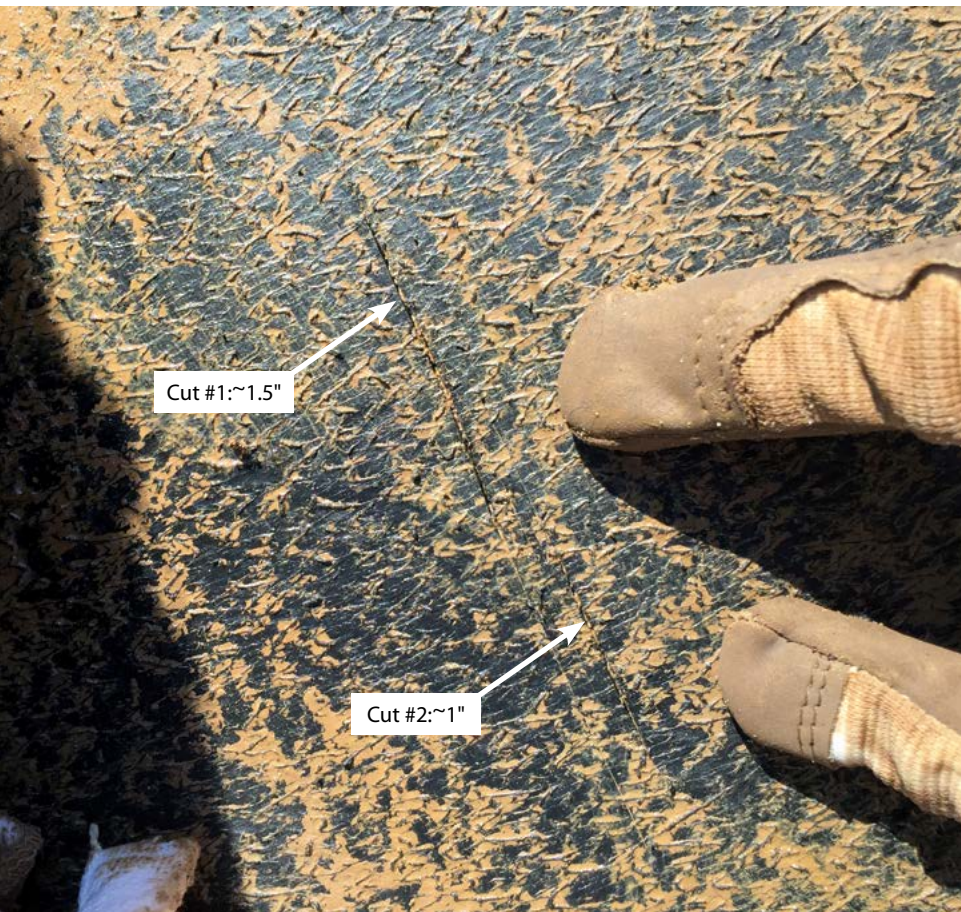
FIGURE 2 Two knife slices through an installed geomembrane located during dipole ELL survey (after cover soil placement)—likely due to cutting either a patch or geotextile on top of the geomembrane installation at that location

Common bad practices repeatedly noted in the field by the authors on numerous sites under these conditions include cutting on top of the installed geomembrane (**Figure 2**), the vacuum test method not being performed correctly (**Figure 3**), straight-line damage remaining under repair patches, and a lack of a paper trail or cross-checking documentation to avoid unacceptable construction practices, such as failing trial seams before welding.

Cutting directly on top of the installed geomembrane should never happen on a job because it creates an unnecessary risk for damage. Even with a hook blade, gouges and cuts can and will occur. If they are found and fixed, having to complete extra repairs compromises the integrity of the liner.

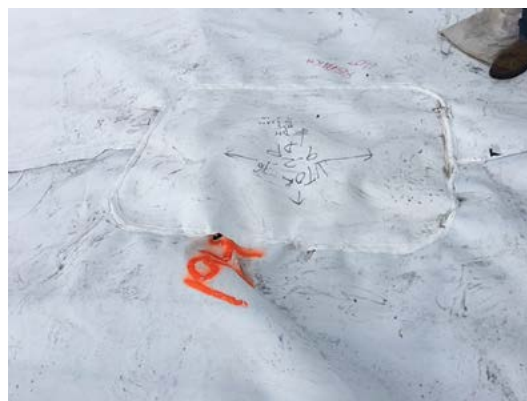
FIGURE 3 Poor execution of the extrusion weld and subsequent vacuum test

In **Figure 3** there is an obvious gap in the weld, which is present on the bottom side of the photograph where the weld crosses the orange paint. The entire patch is

shown because the acronym “VTOK” is a common industry abbreviation for “Vacuum Test Okay” (meaning it passed the vacuum test). However, given that the vacuum chamber would have been placed directly over the gap in this weld, a passing test is impossible if the test was performed correctly.

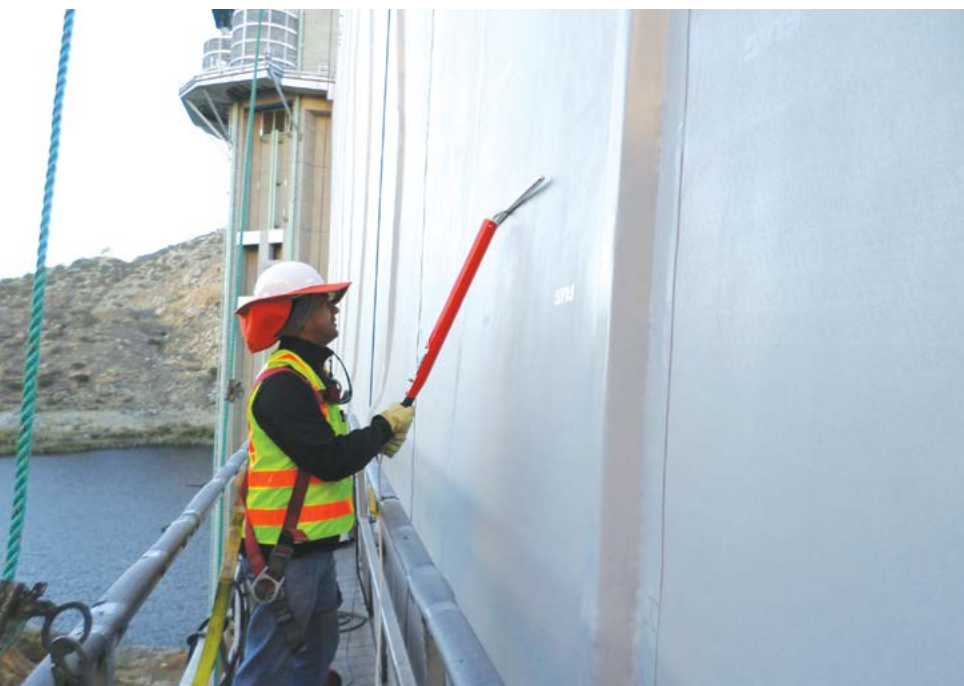
FIGURE 5 High-voltage arc testing, which was formalized in the U.S. in 2014 as ASTM D7953, has enabled bare geomembrane testing on applications that were previously unfeasible, such as this geomembrane-faced concrete dam.

ELL surveys are probably the best return on investment for geomembrane installation CQA, since they get straight to the heart of geomembrane leakage: holes. Installing a geomembrane without checking it for leaks after the end of construction makes no sense. ELL can be performed by the geomembrane installer as part of construction or by a third-party testing company. It can be performed while the geomembrane is bare or after cover material placement, or both. There is an appropriate ELL method for virtually any kind of geomembrane installation. One example is shown in **Figure 5**.
